Regional Reservoir Soil-Cement Cracking Fact Sheet

The C.W. Bill Young Regional Reservoir has operated since 2005 and is a vital part of the regional drinking water system, providing essential water storage during wet times of the year for use during dry times. In December 2006 during inspections of the reservoir, cracking was found in the flat-plate, soil-cement, erosion-control layer lining the interior of the reservoir.

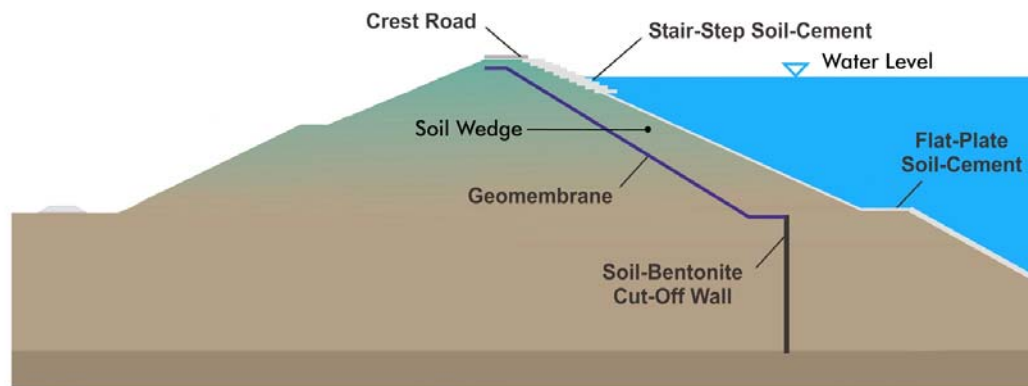
Reservoir Cross-Section

The erosion control component of the reservoir consists of a flat-plate soil cement layer and a soil wedge. These layers protect the deeper geomembrane, a waterstop that prevents water from leaking through the reservoir embankment.

At the widest part of the base, the reservoir embankment is 300 feet wide.

The areas of cracking are occurring only in the erosion control interior liner. To date, cracking has been found along nearly 40 percent of the interior layer in the reservoir. With future use, Tampa Bay Water anticipates other areas to experience similar problems until the underlying problem is fixed.

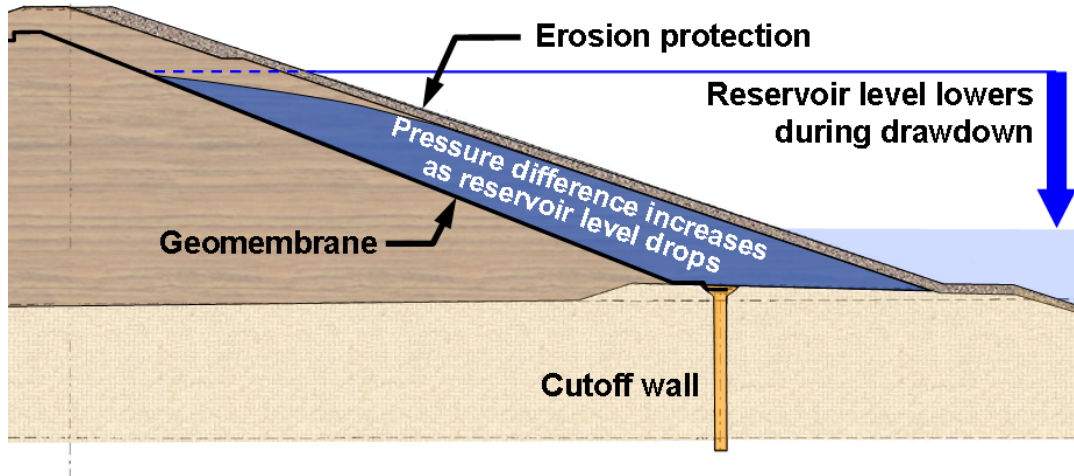
High Water Pressures in the Erosion Control Layer Cause Cracking

A comprehensive analysis by Tampa Bay Water's system engineer has determined that water trapped between the soil cement lining and the geomembrane causes high water pressure that leads to cracking, soil wedge movement and soil erosion.
